RAILROAD ACCIDENT REPORT

DERAILMENT OF FREIGHT TRAIN H-BALT1-31
ATCHISON, TOPEKA AND SANTA FE RAILWAY COMPANY
NEAR CAJON JUNCTION, CALIFORNIA
ON FEBRUARY 1, 1996

Abstract: On February 1, 1996, Atchison, Topeka and Santa Fe Railway Company freight train H-BALT1-31 derailed at milepost 60.4 near Cajon Junction, California. The conductor and the brakeman sustained fatal injuries; the engineer incurred serious injuries. A fire resulting from the derailment and subsequent rail car pileup engulfed the train and adjacent areas.

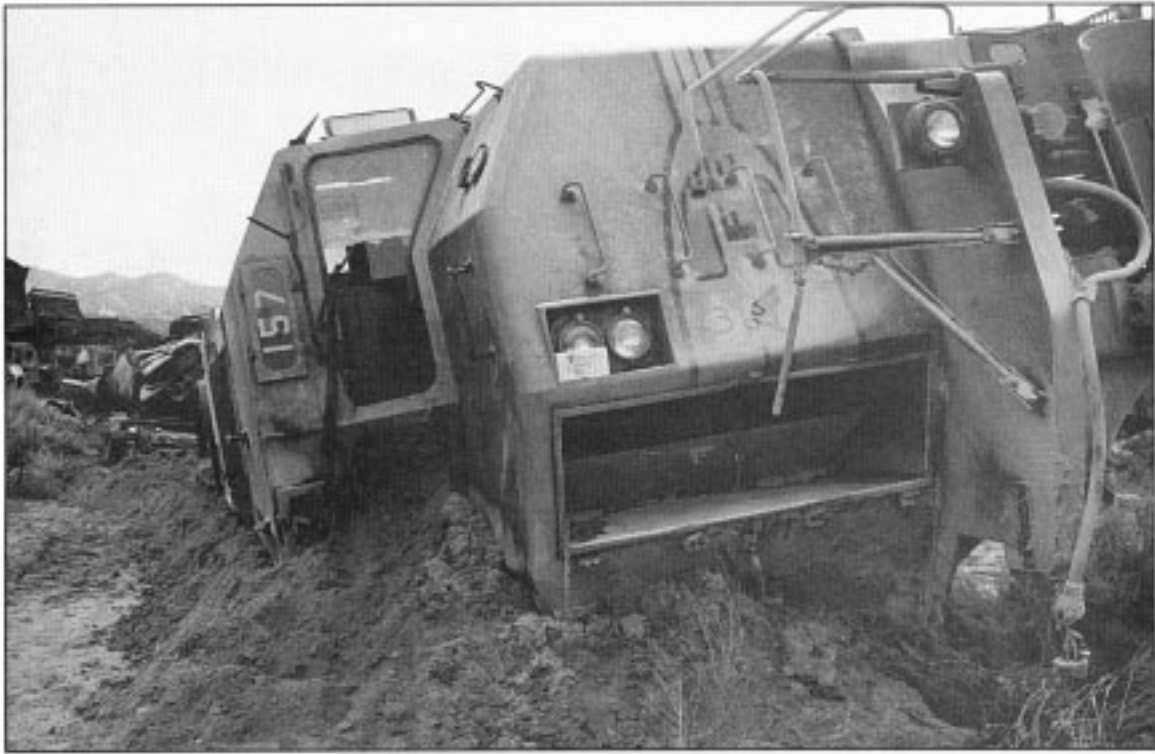
Figure 2.--Lead locomotive ATSF 157

The control compartment windows of locomotive ATSF 157 were broken in front of the engineer's seat on the right side (see figure 2), and the acoustical panel behind the seat was missing. No intrusion was apparent underneath the cab console, and the console appeared to be intact and fixed squarely onto its original mounting. Superficial damage with minor, localized denting about 6 inches deep and also abrasion evidence were on the right side of the

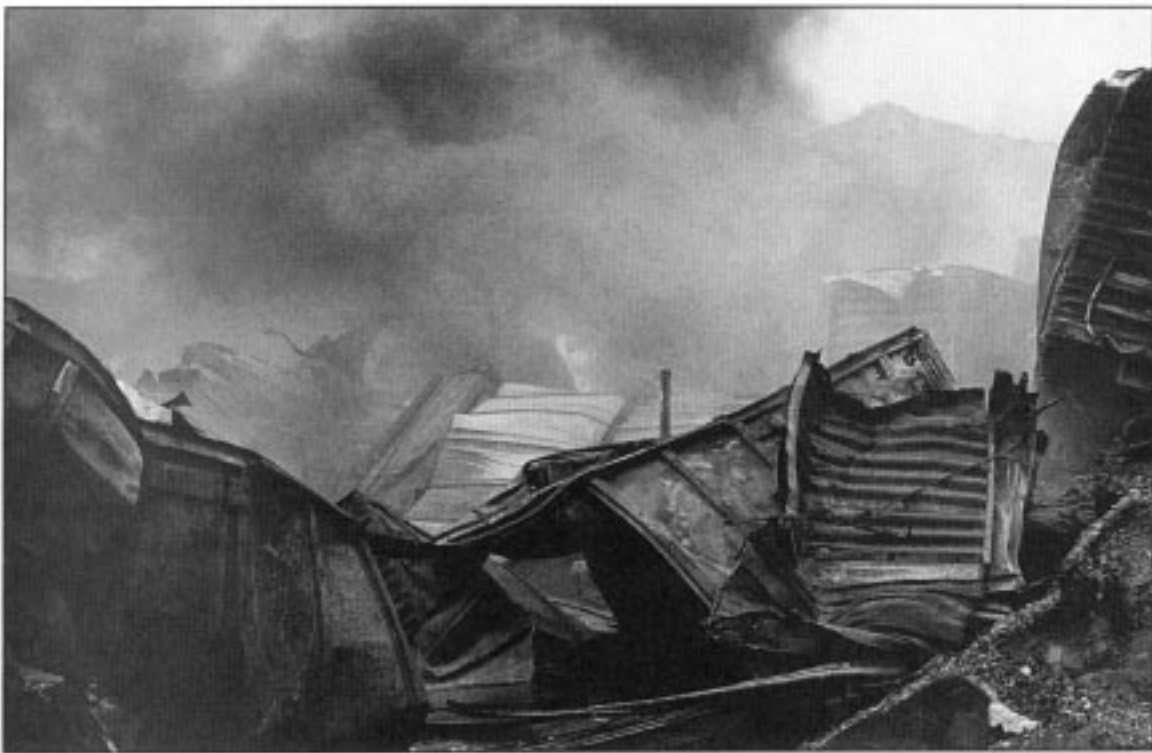
Figure 5.--Freight train H-BALT1-31 derailment pileup of cars

The four locomotives and 45 of the 49 cars derailed, and H-BALT1-31 was compressed into a 400- to 500-foot long pileup of cars. (See figure 5.) Five rail cars in the pileup contained hazardous materials. (See figure 6.) In addition, two underground pipelines, which transported petroleum products, were near the derailment site. A fire ignited after the derailment, and the center of the pileup and the surrounding area were engulfed in flames. Sand in the creek bed around the derailed cars north of the trestle and for 0.5 mile south of the trestle was burned. The conductor and the brakeman, who had sustained fatal injuries, were found, respectively, partially buried in the sand 20 feet south and 30 feet west of the trestle and lying in the burned sand creek bed 30 feet south and east of the trestle.

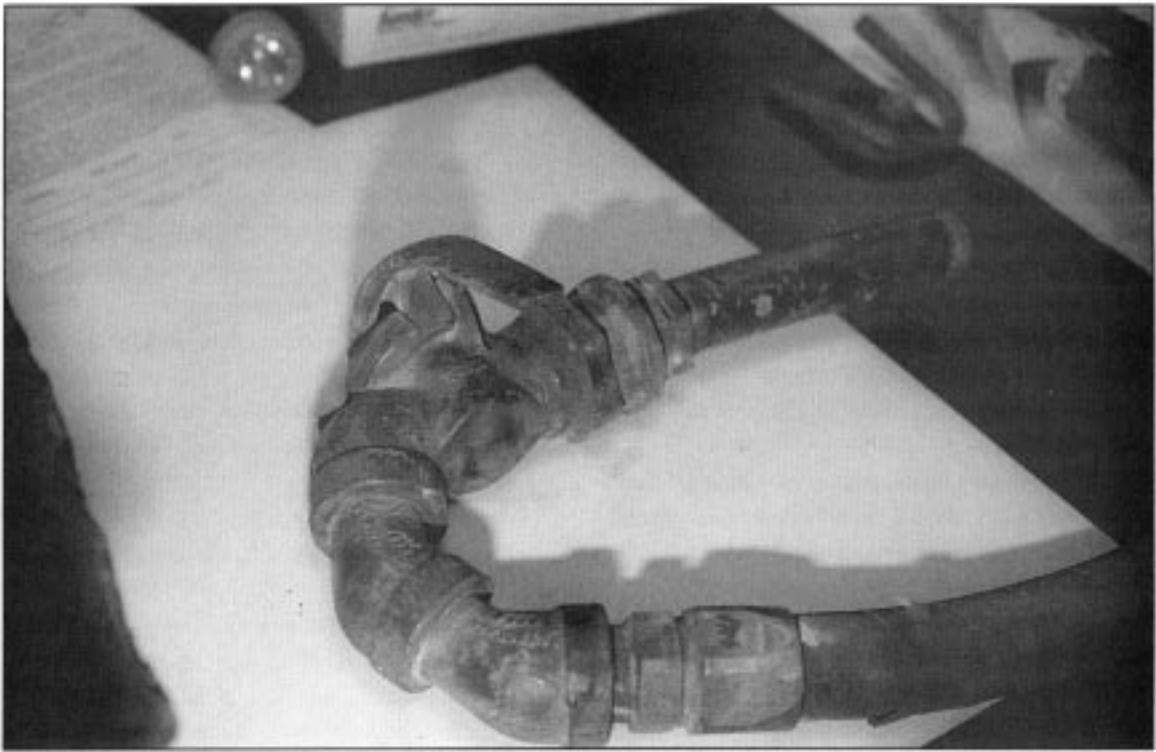
Figure 8.--Angle cock of flat car ATSF 92018

The ATSF wrote the Safety Board on October 7, 1996, about its consultant's findings on the car ATSF 92018. The carrier concluded that according to the findings, the angle cock on car ATSF 92018 had been "closed prior to the fire and closed prior to the derailment." The Safety Board laboratory noted that this angle cock was in the closed position when the fire reached its location.

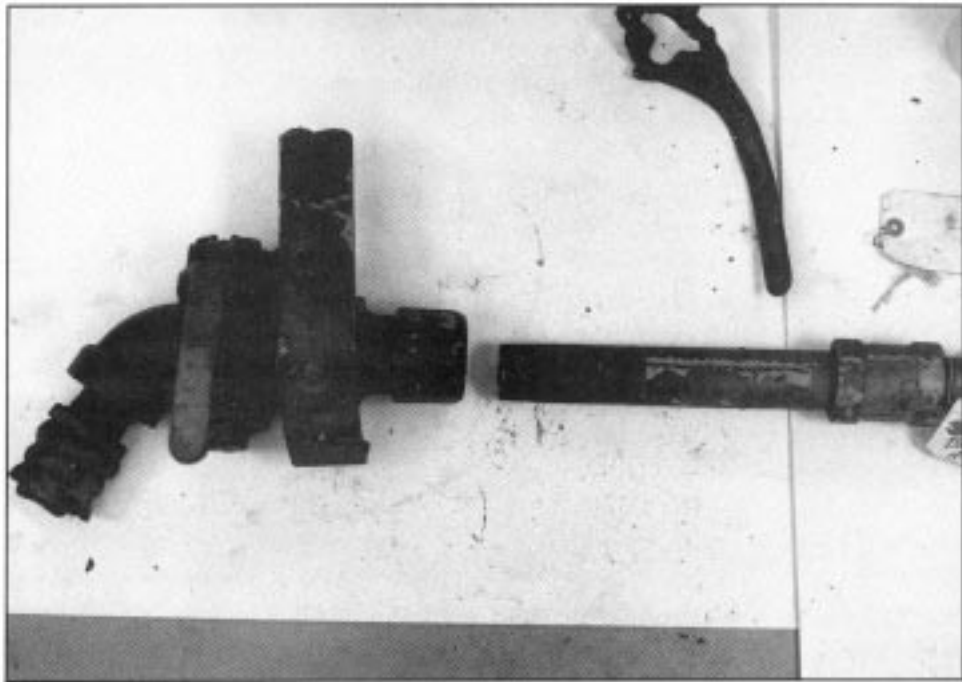
Figure 9.--Angle cock of tank car ACFX 84070

On February 10, 1996, the EPA allowed the ATSF contractors on site. ATSF supervisors then notified the subcontracted wreckage clearing personnel to recover all angle cocks found at the scene. Two subcontractors were shown an angle cock on a box car in the debris, and when they returned to the wreck site entrance, they noticed a wrecked car (ATSF 92018) along the right-of-way, which had an attached angle cock. (See figure 8.) The subcontractors notified the ATSF supervisors about the angle cock. The supervisors observed that the angle cock was closed and instructed the subcontractors to retrieve it. This angle cock, which was the first of six angle cocks found in the closed position, was removed, decontaminated, and given to the supervisors. Two of the six angle cocks, one later matched with the B end of car ACFX 84070 and the one from car ATSF 92018, had sustained no major damage.
