RAILROAD ACCIDENT REPORT

DERAILMENT OF FREIGHT TRAIN H-BALT1-31
ATCHISON, TOPEKA AND SANTA FE RAILWAY COMPANY
NEAR CAJON JUNCTION, CALIFORNIA
ON FEBRUARY 1, 1996

Abstract: On February 1, 1996, Atchison, Topeka and Santa Fe Railway Company freight train H-BALT1-31 derailed at milepost 60.4 near Cajon Junction, California. The conductor and the brakeman sustained fatal injuries; the engineer incurred serious injuries. A fire resulting from the derailment and subsequent rail car pileup engulfed the train and adjacent areas.

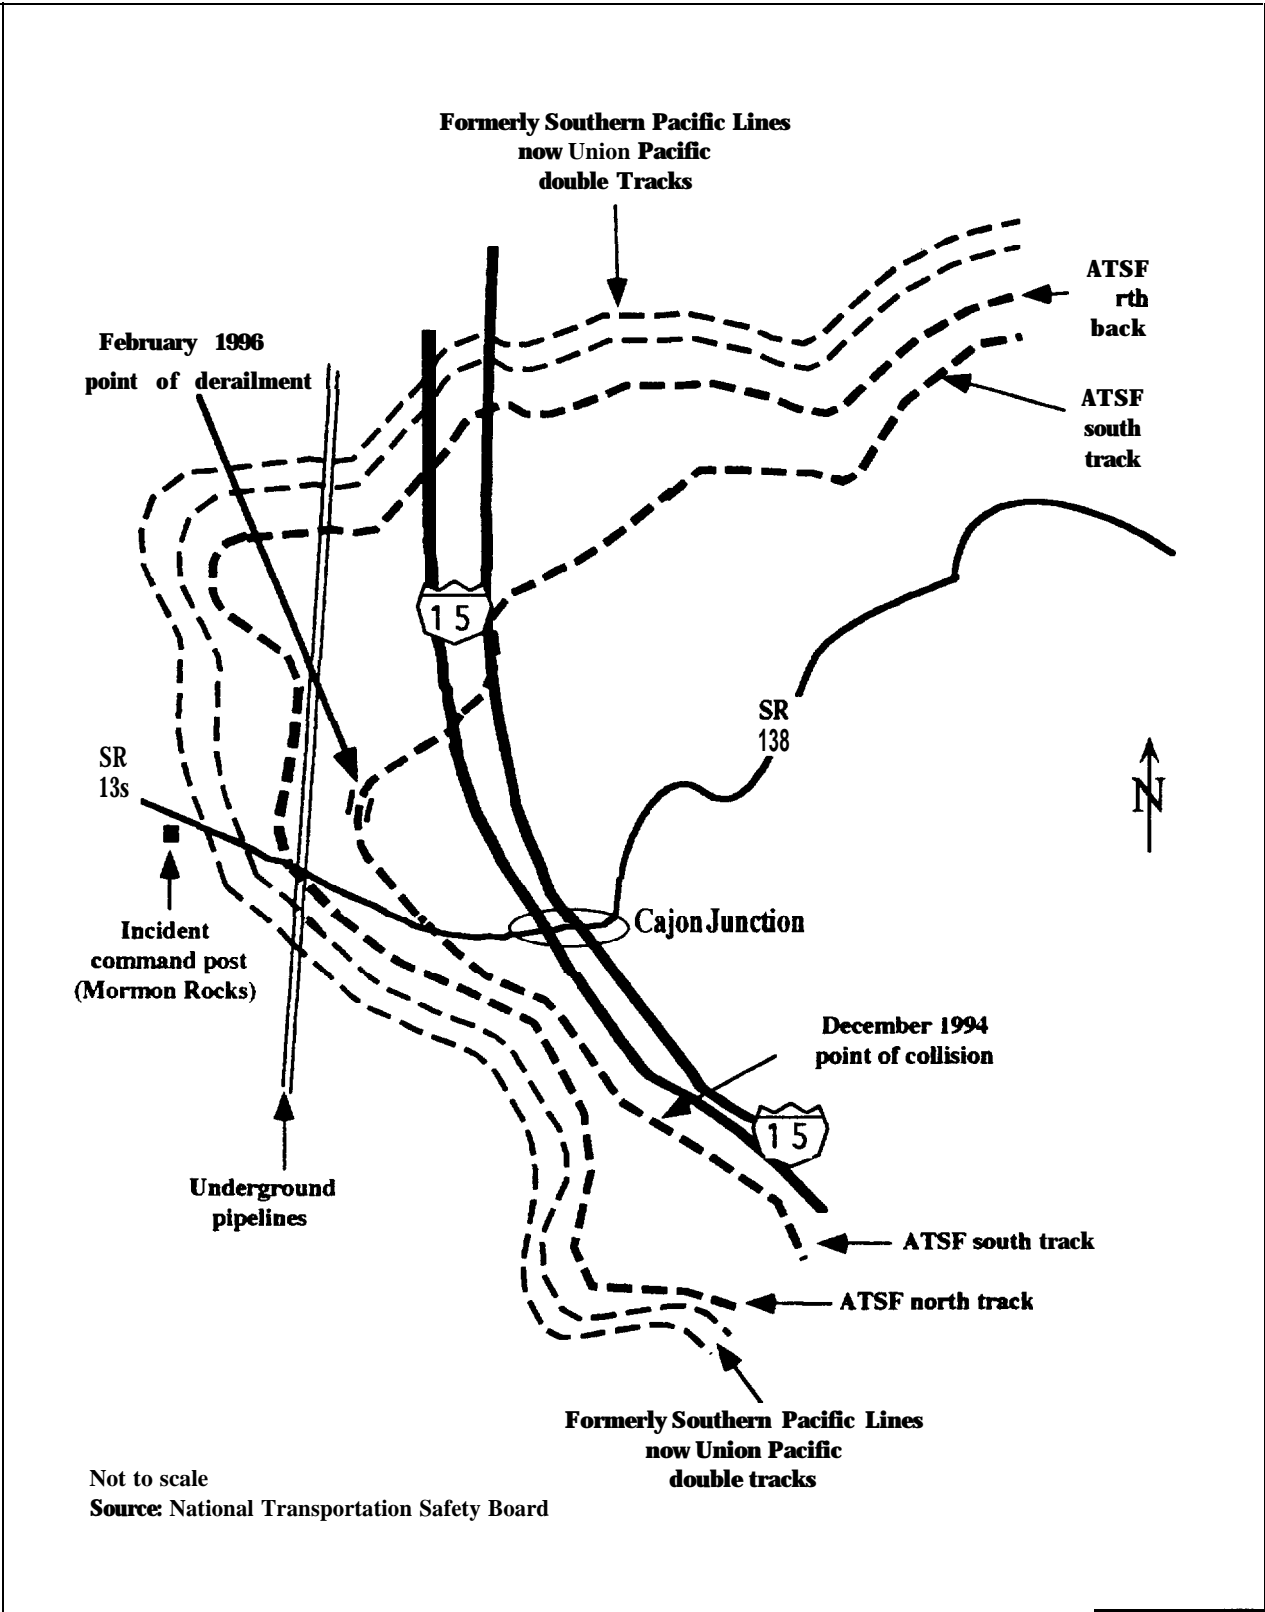
Figure 7.--Freight train H-BALT1-31 derailment site

ordered the freeway closed⁸ at 4:24 a.m. and began at 4:29 a.m. evacuating the area around the SR-138/I-15 interchange as a safety precaution. (See figure 7.)

The director of train handling testified that after the December 1994 Cajon Pass accident²¹ at MP 61.55 (see figure 7), the ATSF had committed to install two-way ETDs and receiving units on its locomotives, as the equipment became available from manufacturers. As a result of the Safety Board investigation of the 1994 collision, the Safety Board recognized the following safety
